Historic Façade Materials Assessment Findings Report
for
1059 Willamette Street
Eugene, Oregon

Assessment conducted by
Shannon Sardell, Balance Architecture
with assistance from
Aaron Jensen from Pioneer Waterproofing
October 2019

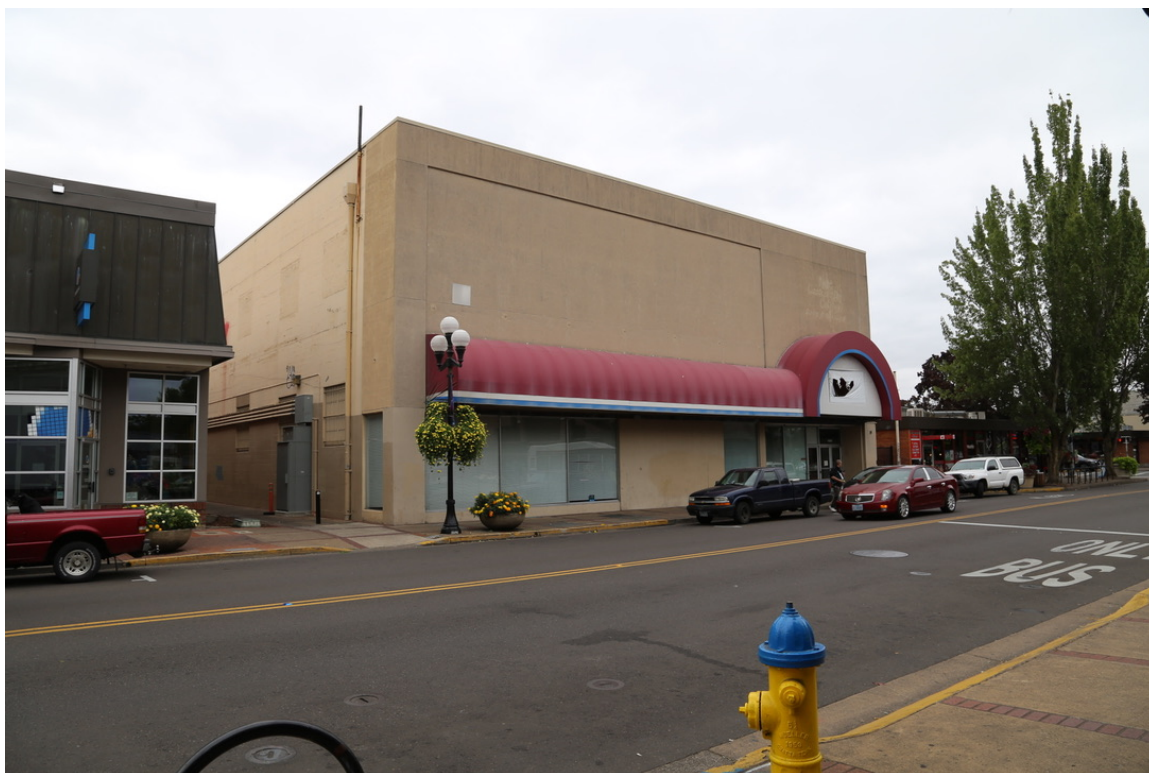
Figure 2 Current photo of the vacant building at 1059 Willamette Street, 2019. looking south east from Willamette Street. Photo credit, author.

Current conditions of the Willamette Street elevation included three large windows and an entry sequence under a large arched fabric awning and canopy stretching the length of the building. There are currently no openings in this elevation above the street level and the blank surface is articulated only with an inset panel of the same EFIS north of the shadowed remains of the Lane Community College Downtown Center sign that has been removed.

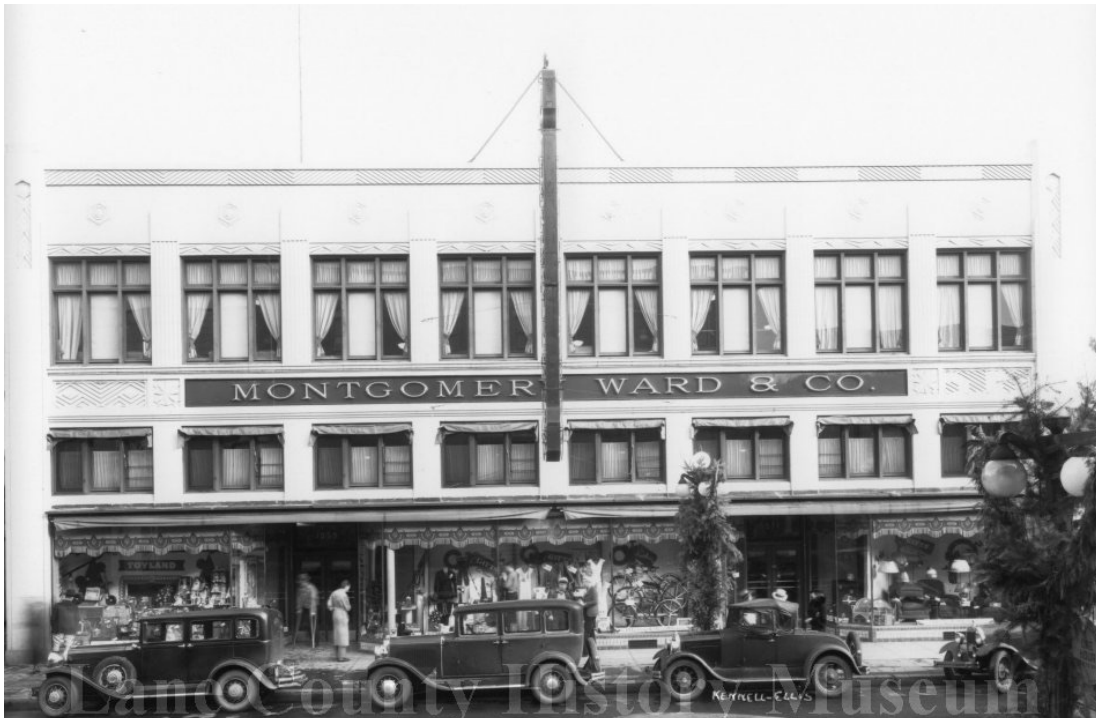
Three areas were selected for inspection based on a historic photograph of the elevation taken in 1935 (Figure 3). These areas were selected for their location to render information about transom windows above the awnings, the condition of the sign band above the transoms, the

Figure 3 Historic photo of the Montgomery Ward and Co. building at 1059 Willamette Street, 1935 looking east from Willamette Street. Photo credit, Lane County Historical Museum.

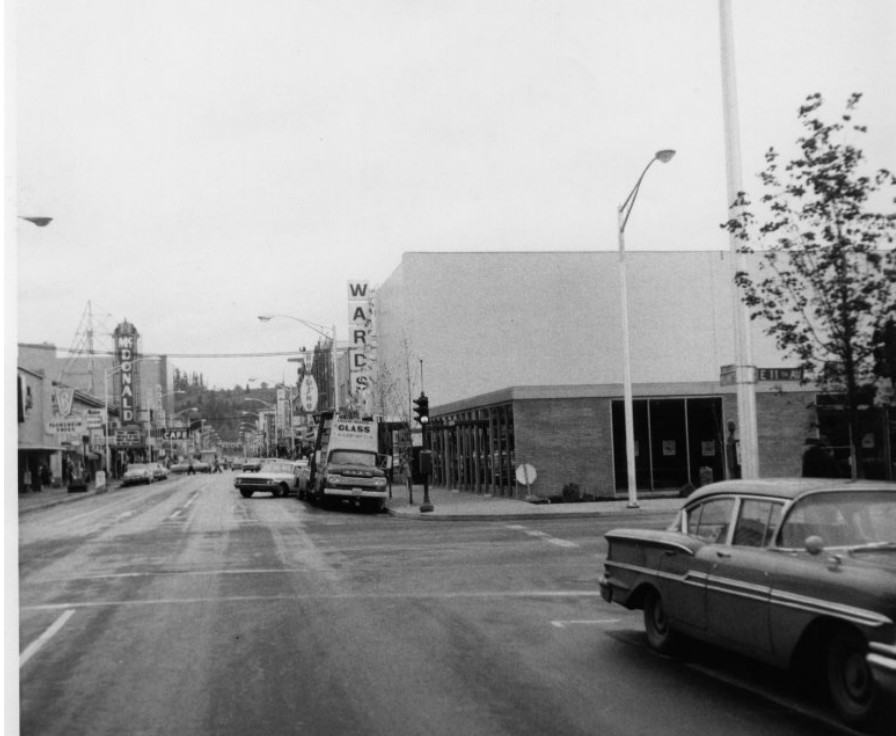
Figure 4 Historic photo of the Montgomery Ward and Co. building at 1059 Willamette Street, 1965 looking north t from Willamette Street with 11th Avenue intersection in the foreground. Photo credit, Lane County Historical Museum.

At this juncture in the inspection a 1965 image of the building from the Lane County History Museum was compared to the materials that were observed (Figure 4). It was concluded that the entire Willamette Street elevation was updated just before the 1965 picture was taken. These materials and mortar were popular in retail store front construction at that time.

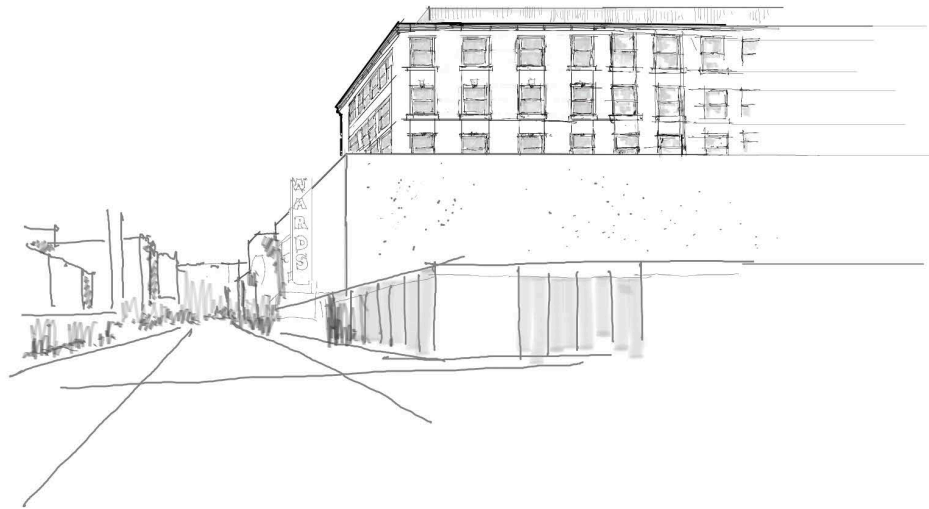
Though not original to the date of construction, the masonry surface uncovered on the Willamette Street elevation is more than 50 years old and is significant to the commercial developmental history of downtown Eugene. This elevation could be restored using the 1960's materials and proportions. It would provide a street front scale appropriate for the context of other historic buildings along Willamette Street. Further preservation of the building mass might not be necessary. This type of preservation, called "facadism", would only be appropriate or possible if a ground floor commercial store front was used and new openings in the masonry along Willamette Street were not necessary in the existing two-stories. Further building square footage above two stories could be added with a modest set back at Willamette Street.

Figure 10 11 Design sketch of the mid-century modern Montgomery Wards store front with an addition of levels set back and above the existing property. The design and location of additional square footage should be open ended but the approach of preserving the Willamette Street elevation would preserve the scale and context of other buildings along Willamette Street, reuse some of the existing building fabric, and provide an engaging pallet of design potential on the existing site. Credit, Balance Architecture.
